Hastings, Nebraska Area 1 Blight and Substandard Study

September 2017

Prepared for: City of Hastings, Nebraska CRA

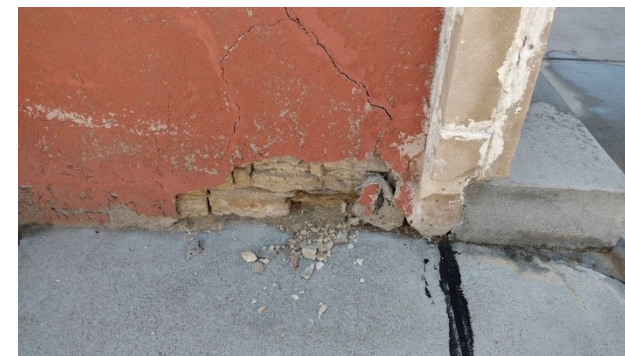
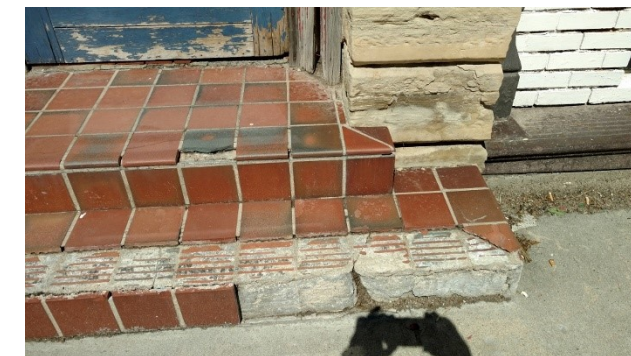
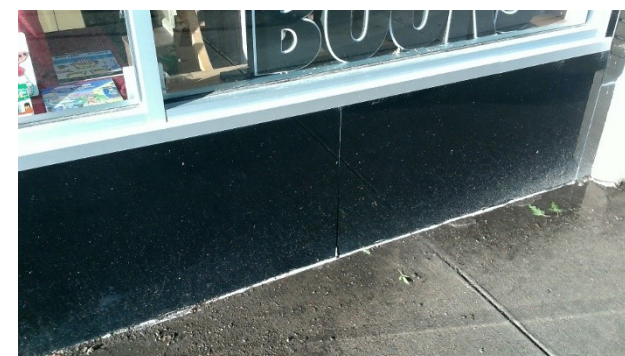
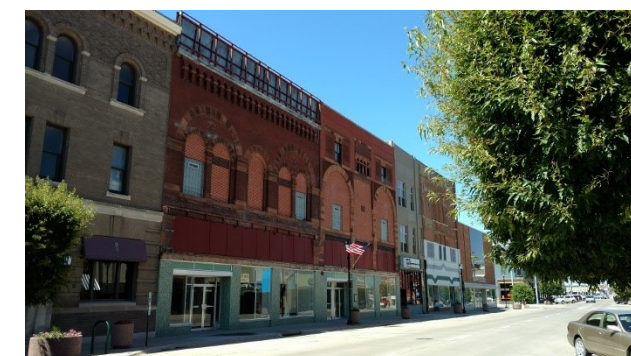
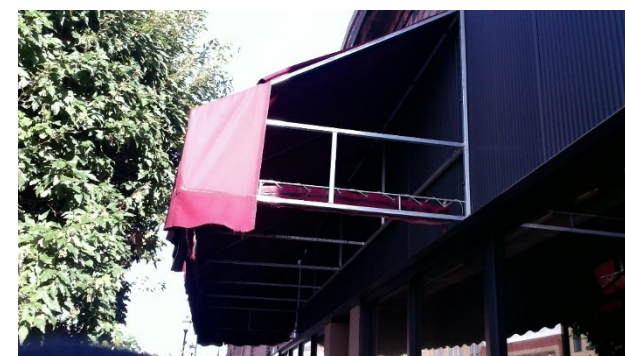
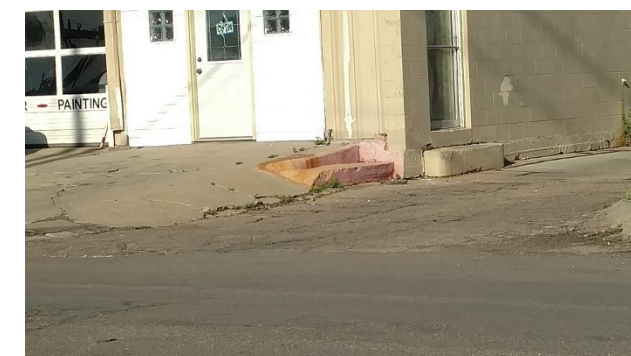
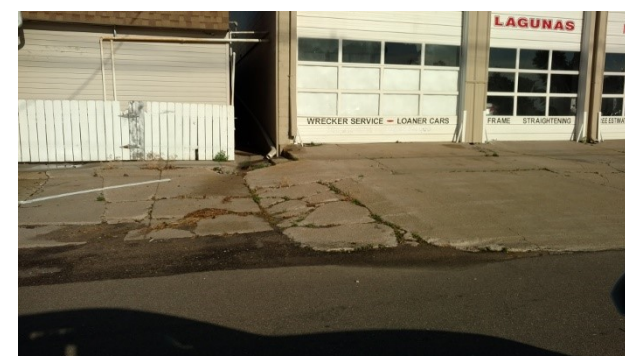
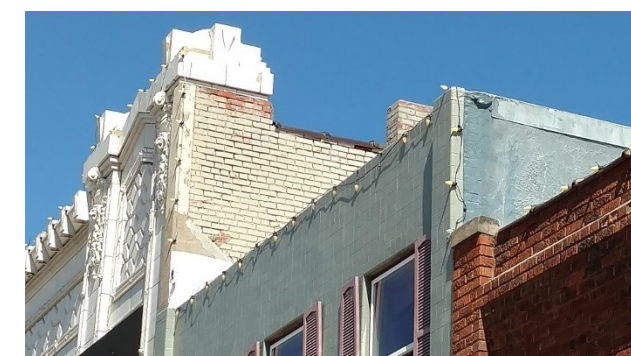
Based upon these data, an assumption has been made that average condition and less would constitute less than desirable conditions due to age and conditions. It is common for older structures to get more maintenance and upkeep in order to maintain a good or higher condition. Even an average structure will show some signs of deteriorating which in turn can become a dilapidated structure in the future if it is not addressed over time. Overall, 90.4% of the structures in this study area are average condition or worse.

Due to the stated conditions found in the Adams County Assessor's data, the condition of the structure is a contributing factor.

Examples of Structural Conditions within the Study Area

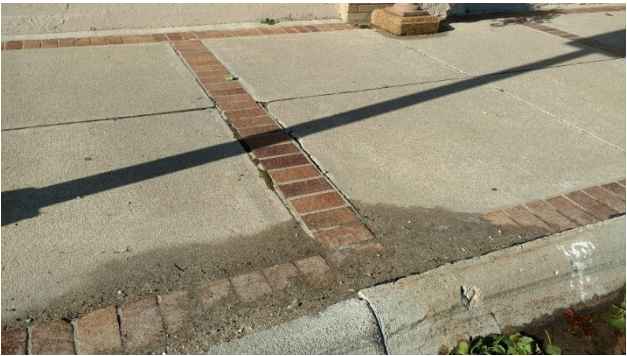
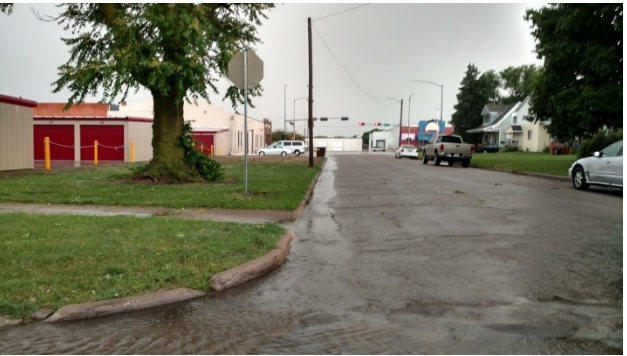
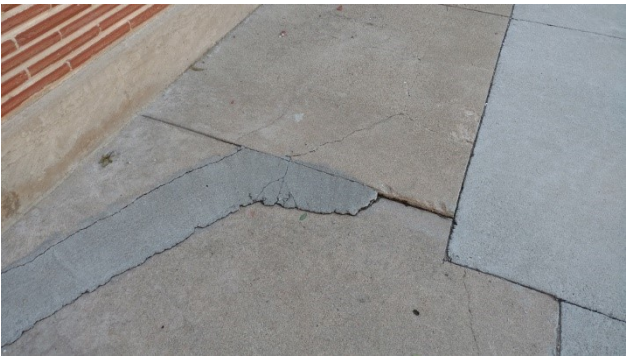
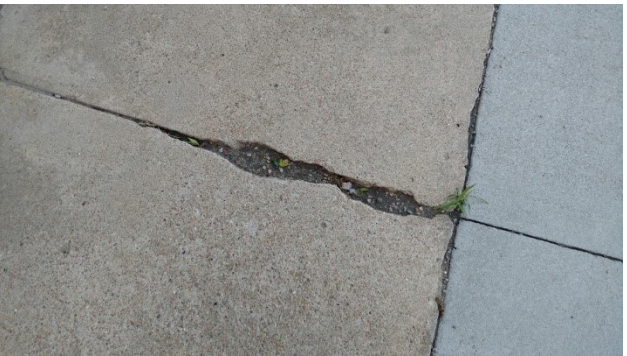
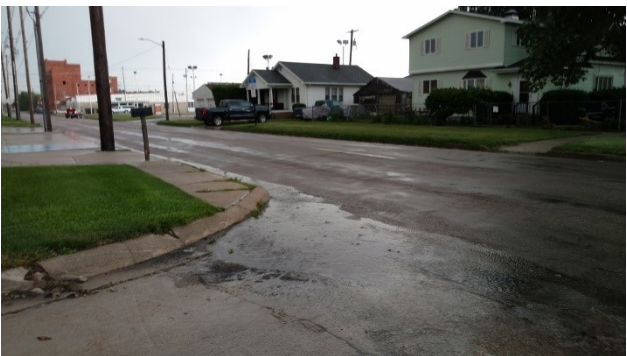
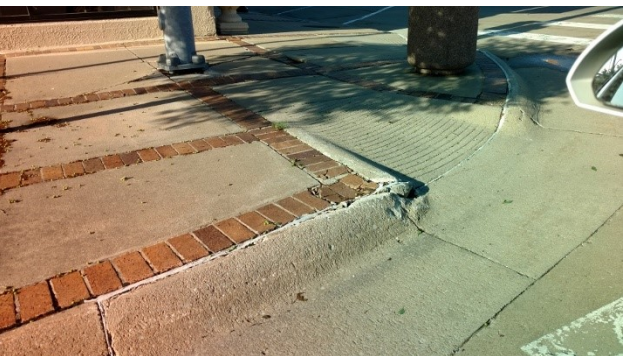
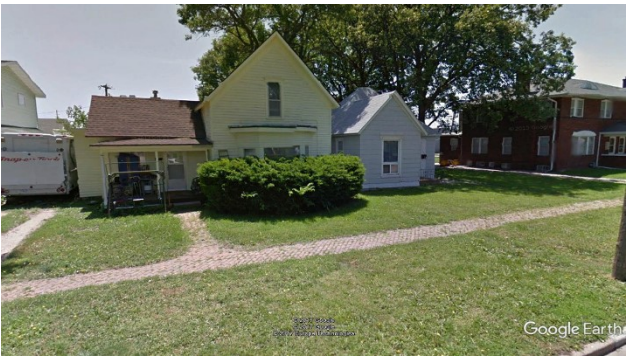
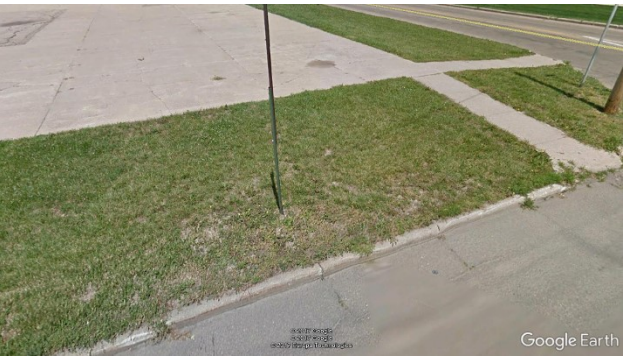
- 12,438 (21.9%) lineal feet of good sidewalk
- 13,120 (23.2%) lineal feet of average sidewalk
- 27,192 (48.0%) lineal feet of poor sidewalk
- 3,890 (6.9%) lineal feet of no sidewalk.

There is only one area which is lacking sidewalk, along 1st Street. Most of the area is directly behind Allen’s but continues around the east side of the stores parking lot. Overall, over 78% of the sidewalk in this study area is considered to be average, poor or completely missing. Even if the average sidewalk condition was factored out of the overall calculation, there would be 54.9% of the sidewalk considered poor or missing. Due to this the sidewalk conditions in the Study Area are considered a contributing factor to a condition of Blight.

Examples of Sidewalk Conditions within the Study Area

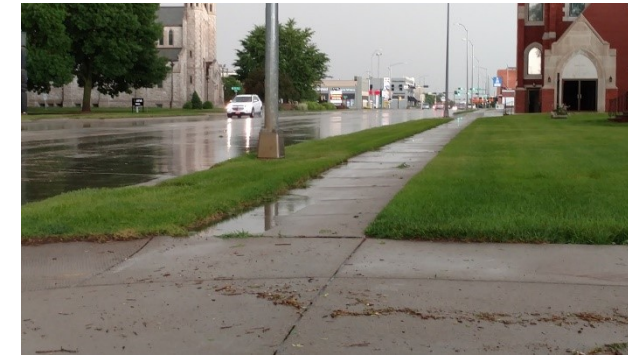
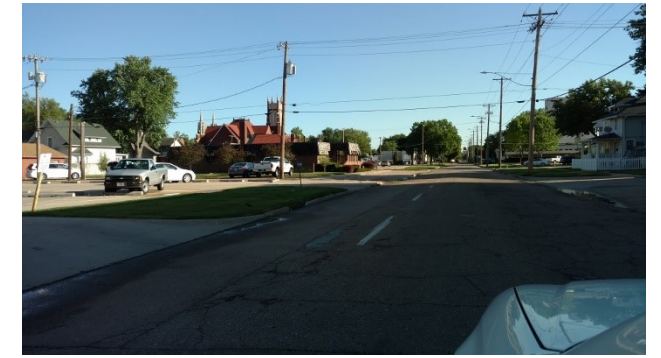
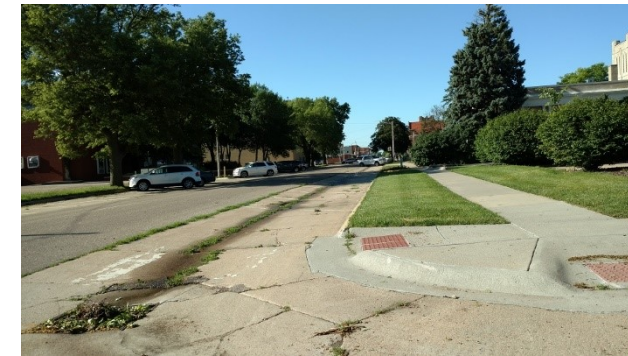
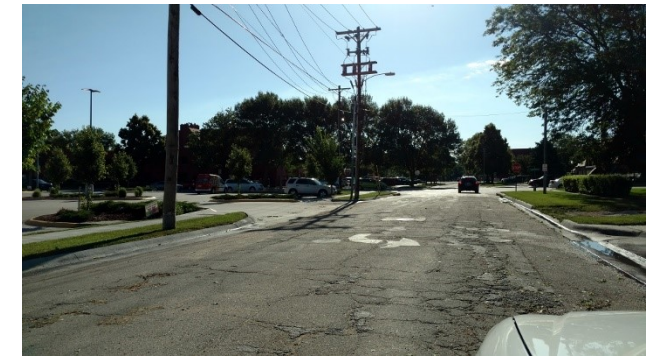
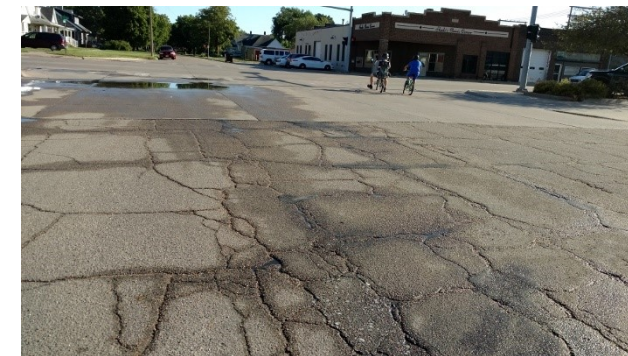
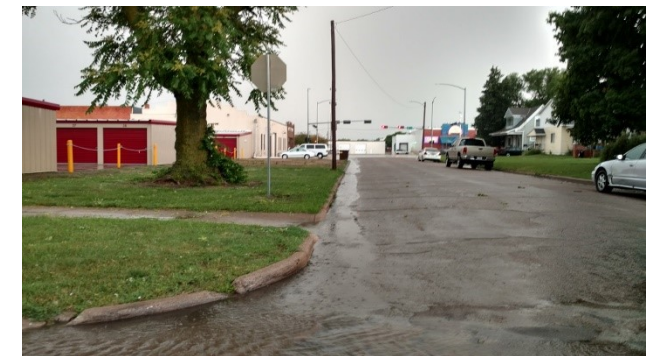
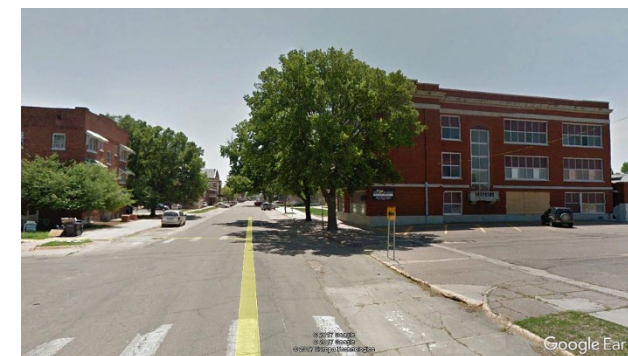
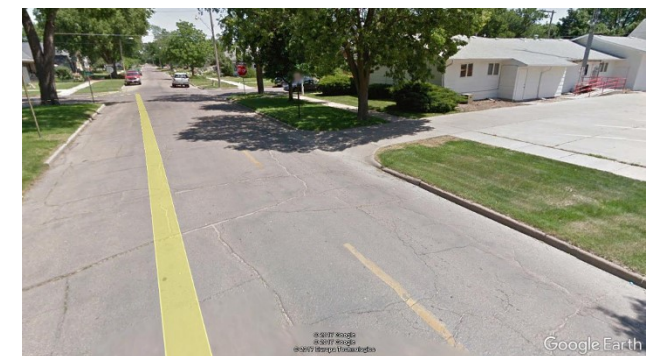
In total, 93.5% of the streets are in a average condition or worse, thus making them in a deteriorating state. However, if you remove the average condition streets from the calculation, Area 1 still has 66.0% of the streets in a state of deterioration. See Figure 5 for the locations of these streets.

Due to the large amount of deteriorating streets, the street conditions would be a direct contributing factor.

Examples of Street Conditions within the Study Area

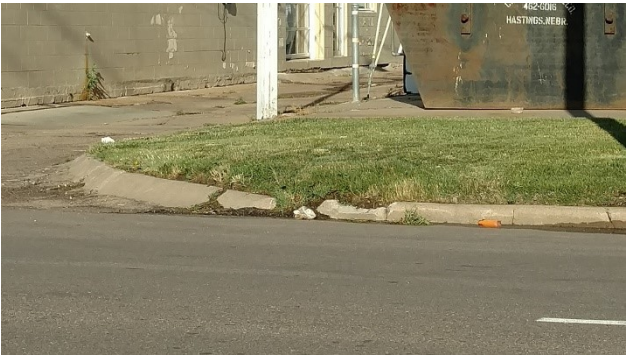
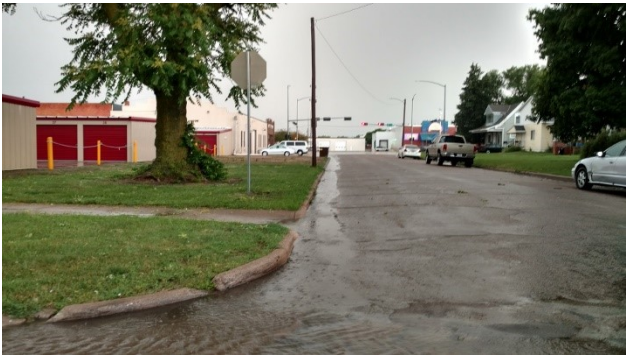
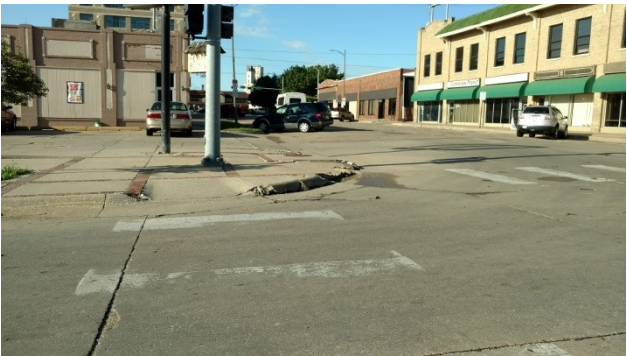
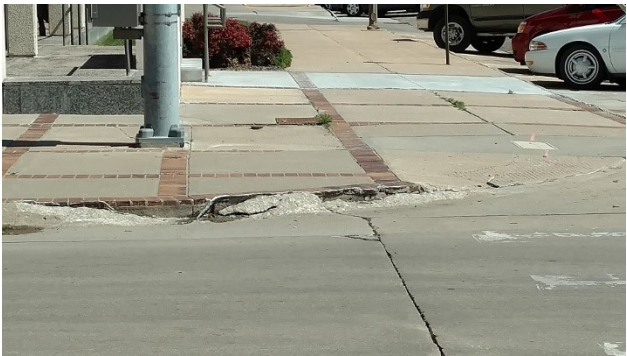
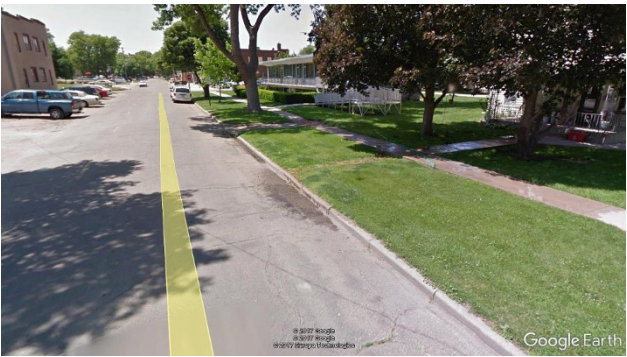
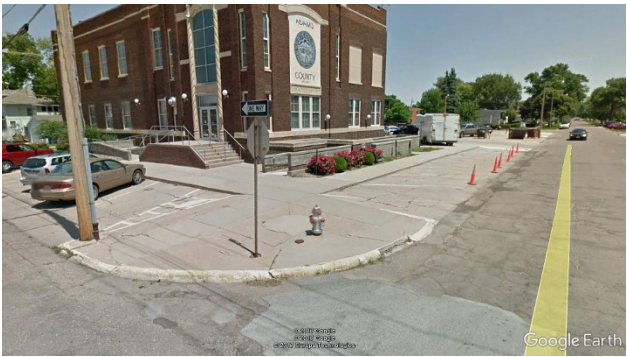
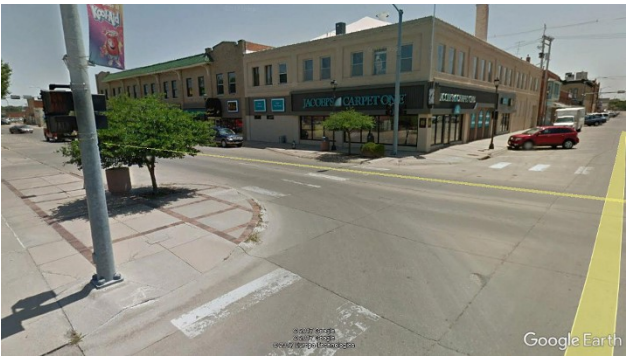
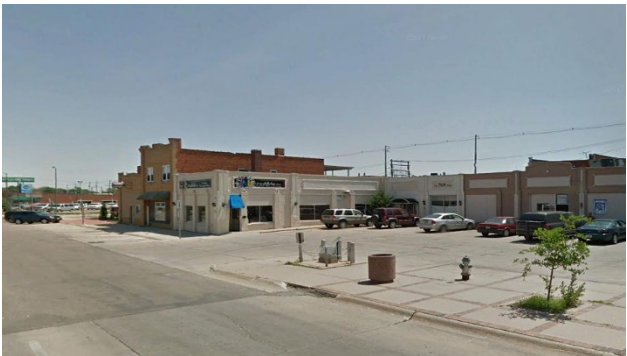
- 5,705 (10.1%) lineal feet of good curb and gutter
- 3,762 (6.7%) lineal feet of average curb and gutter
- 38,381 (68.3%) lineal feet of poor curb and gutter
- 8,383 (14.9%) of missing curb and gutter

In total, 89.9% of the curb and gutter are in a average condition or worse, thus placing them in a deteriorating state. However, if you remove the average condition curb and gutter from the calculation, Area 1 still has 83.2% of the curb and gutter in a state of deterioration. See Figure 6 for the locations of these curb and gutter.

Due to the large amount of deteriorating curb and gutter, the curb and gutter conditions are a direct contributing factor.

Examples of Curb and Gutter Conditions within the Study Area

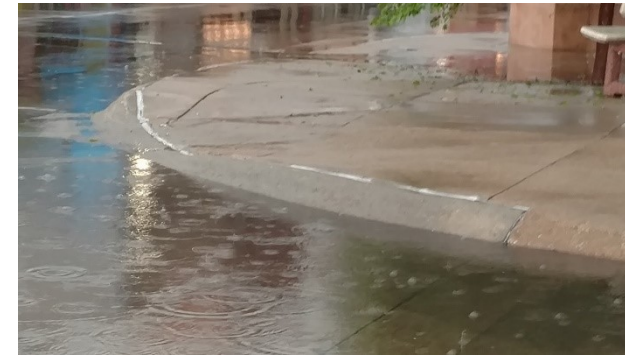
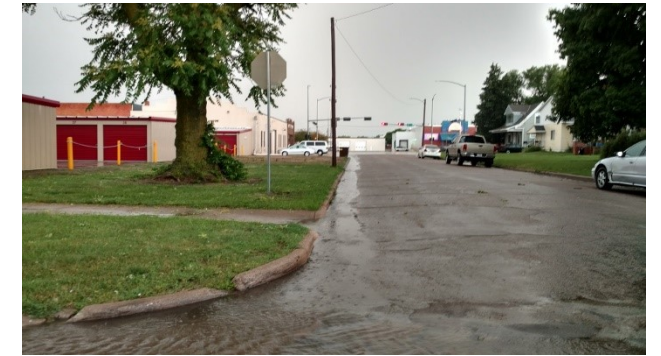
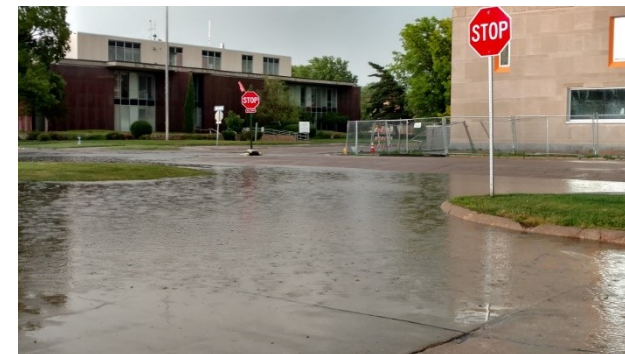
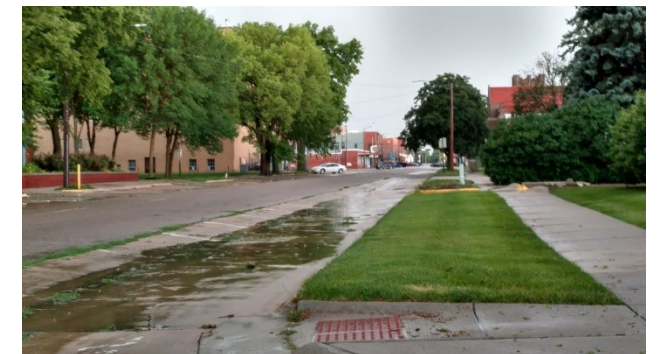
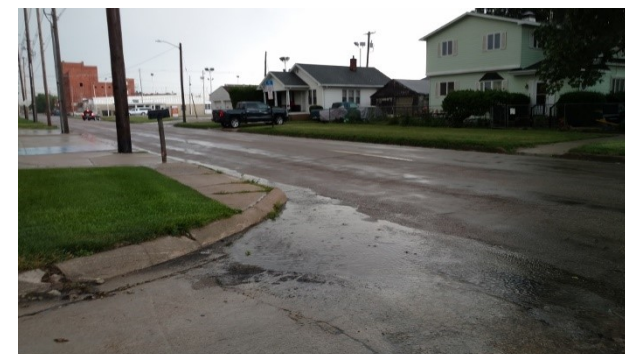
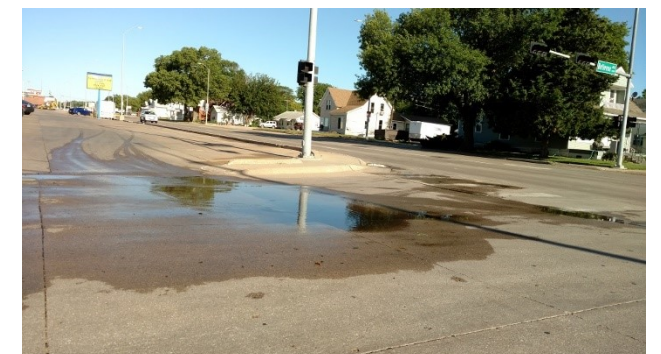
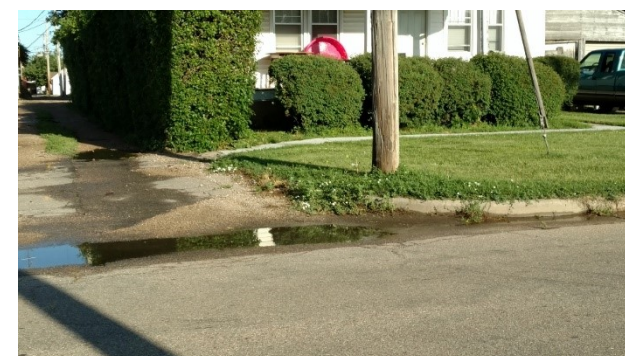
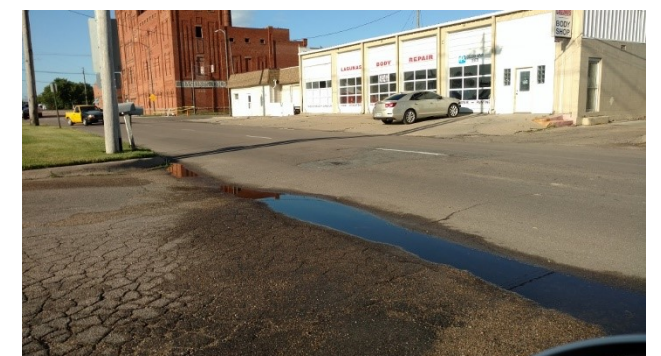
The study area was observed during an evening thunderstorm on June 13th. The storms that evening allowed a direct observation of how the drainage system handled a larger than normal storm. Due to the above average rainfall, the stormwater system had a short term failure to keep pace with the rain accumulations, resulting in short-term flash flood/urbanized flooding incident.

Observations the next morning indicated a number of areas where standing water was still present in the study area. Most of the standing water was due to deterioration of the curb and gutter system in the area. Over time, several key locations in the actual gutter flowline have settled and created a failure in the ability to drain water completely. Therefore, the drainage conditions in Area 1 is impacted directly by the deteriorating/poor curb and gutters throughout.

Due to the drainage issues and in combination with the curb and gutter conditions, drainage issues are a direct contributing factor towards blighting the area.

Examples of Drainage Conditions within the Study Area

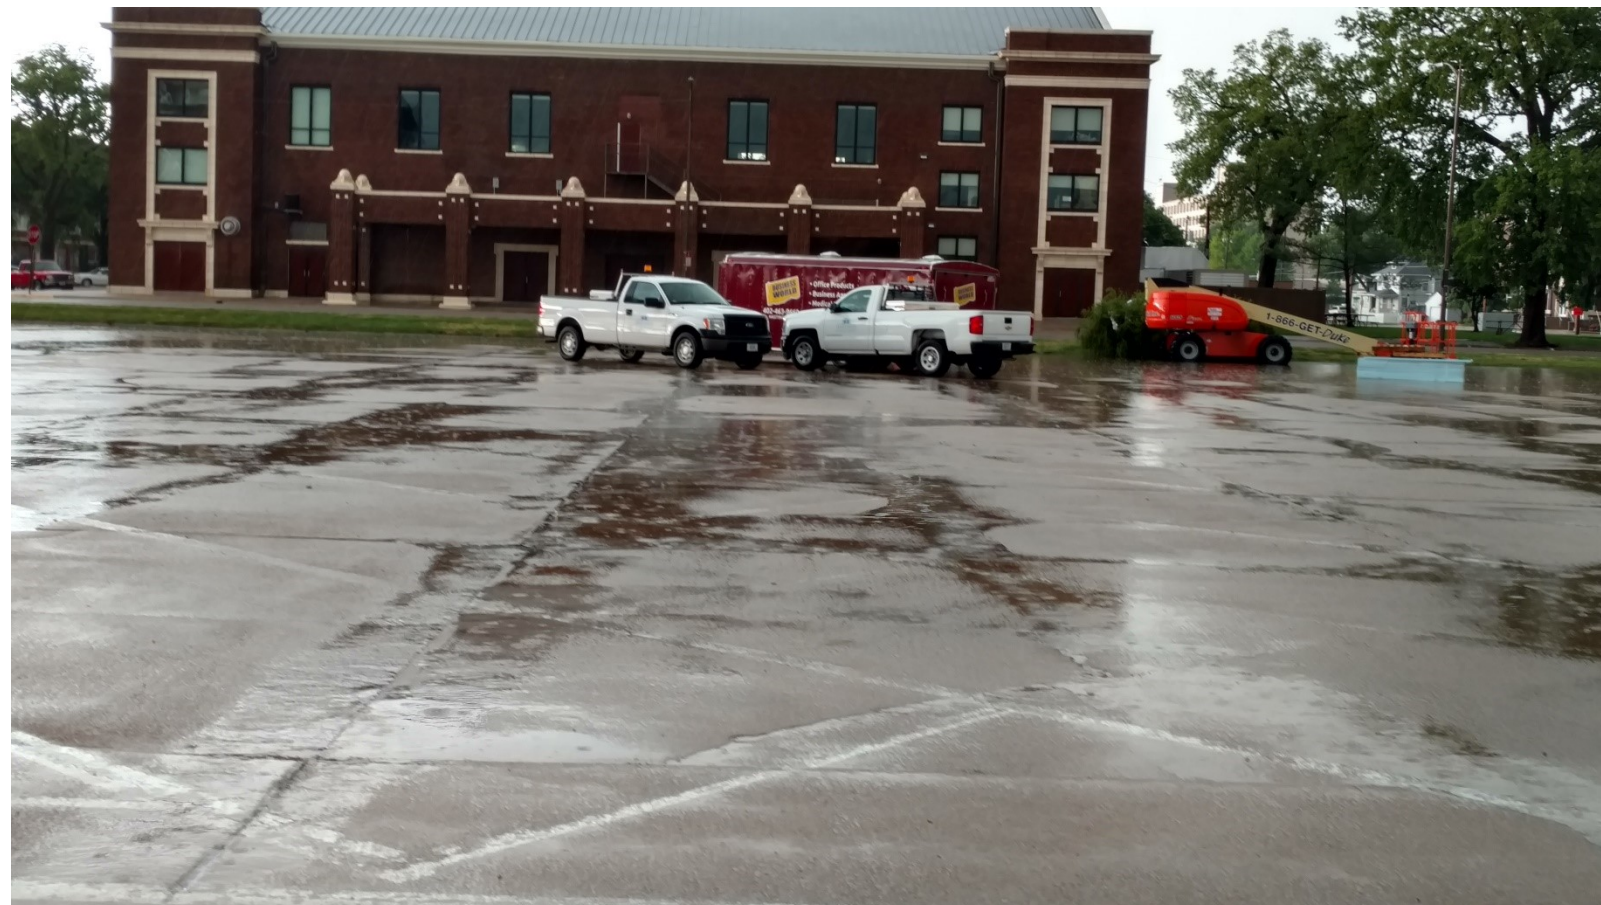
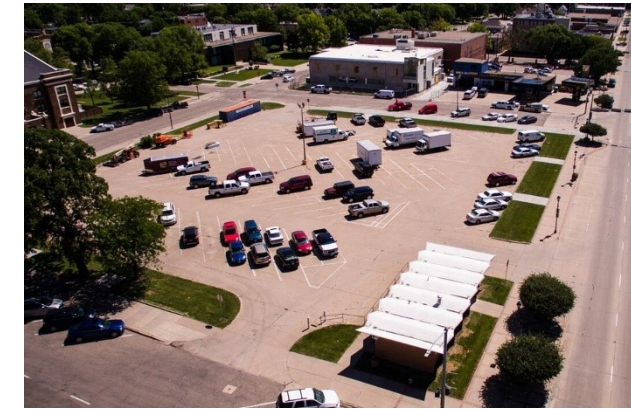
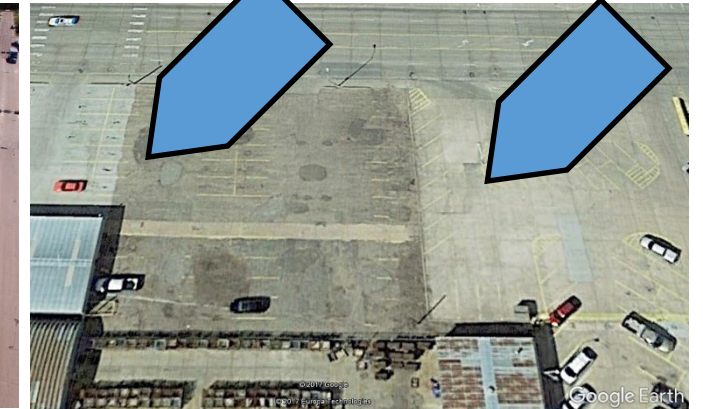
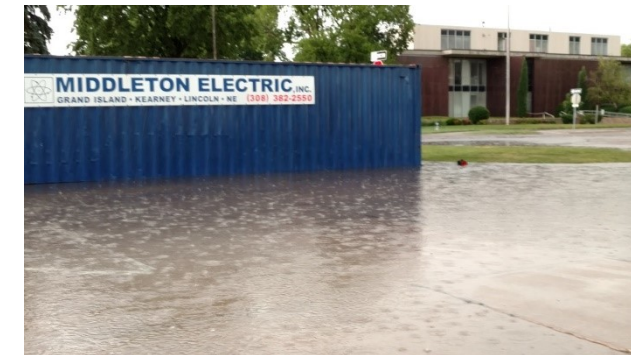
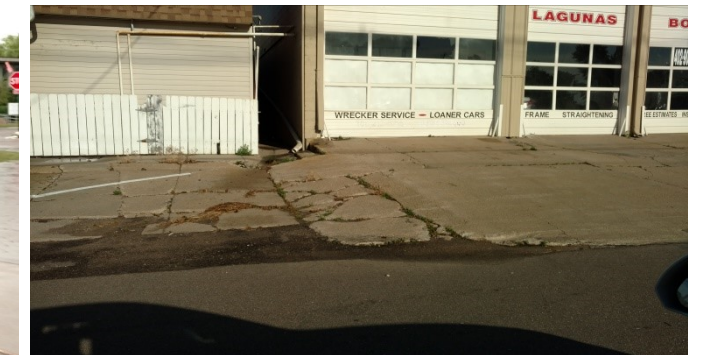
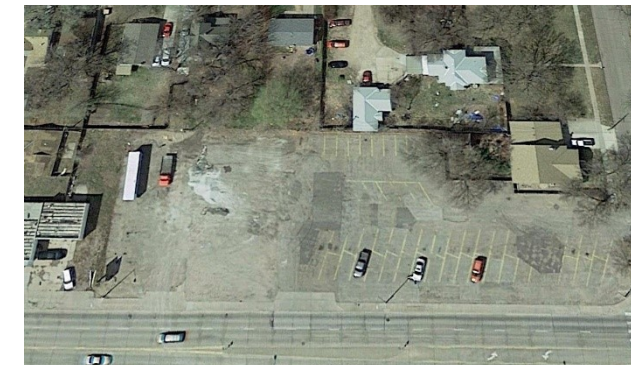
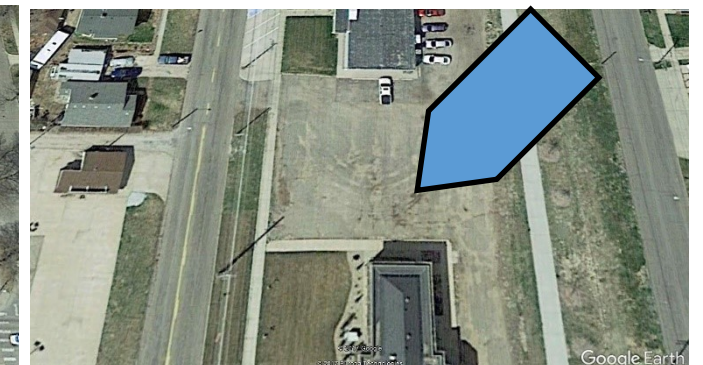
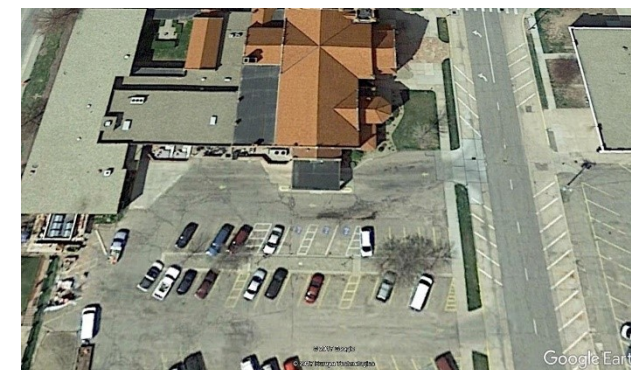
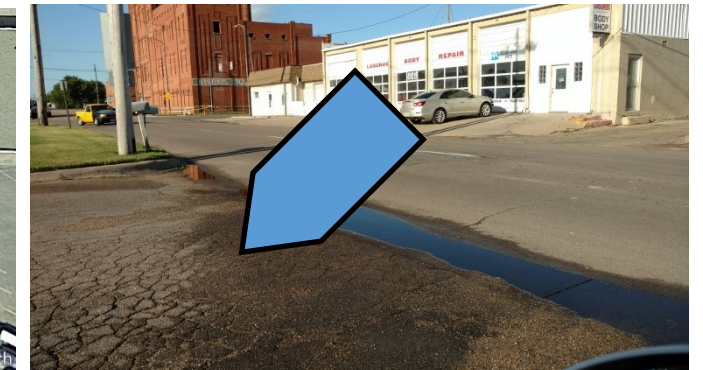
Within Area 1 there are 44 areas where the site improvements were deemed to be in poor condition. Some of these areas are far worse than others and should be improved. One of the most visible locations is the City Parking Area immediately north of City Hall (site of old Adams County Courthouse). The City parking area is seeing surface breakup in places and the photo to the right shows the drainage issues on the site from the June 13th rain event.

Due to the condition of multiple sites and the lack of improvements, specifically the condition and type of the paving, Site Improvements issues are a direct contributing factor towards blighting the area.

Examples of Site Improvement issues within the Study Area

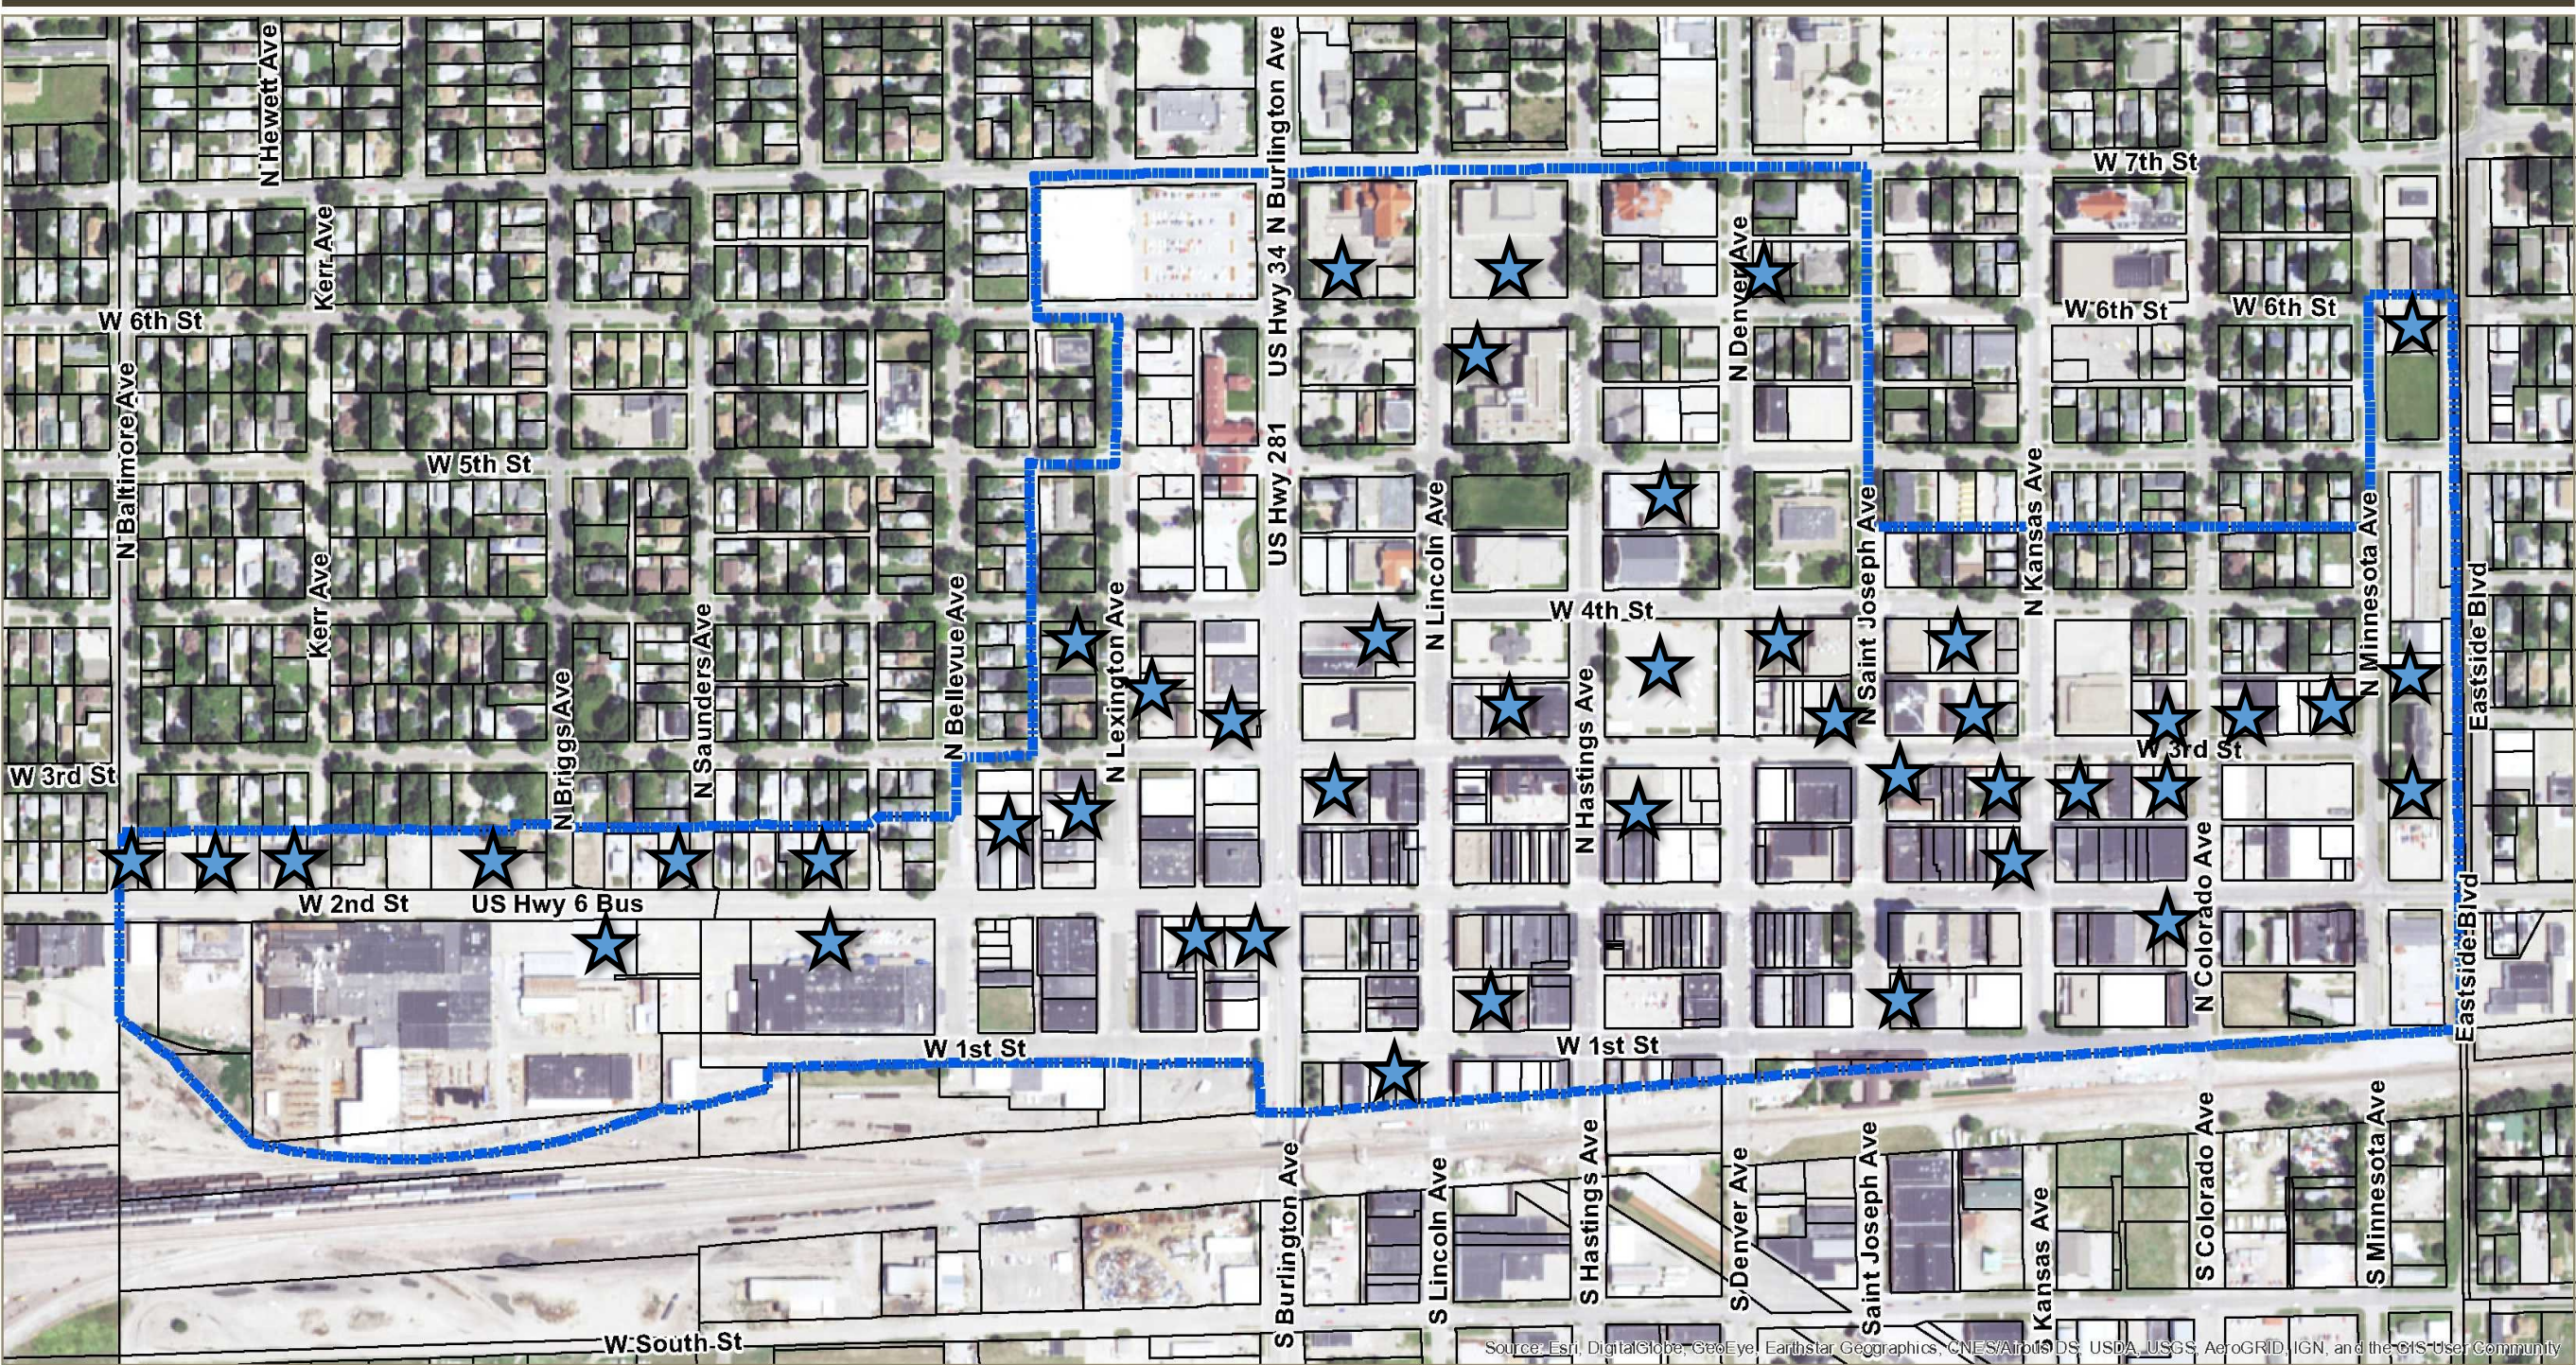
Figure 8
Site Improvements—Deterioration

Area 1 (160 Acres) Site Improvements showing deterioration and/or not hard-surfaced

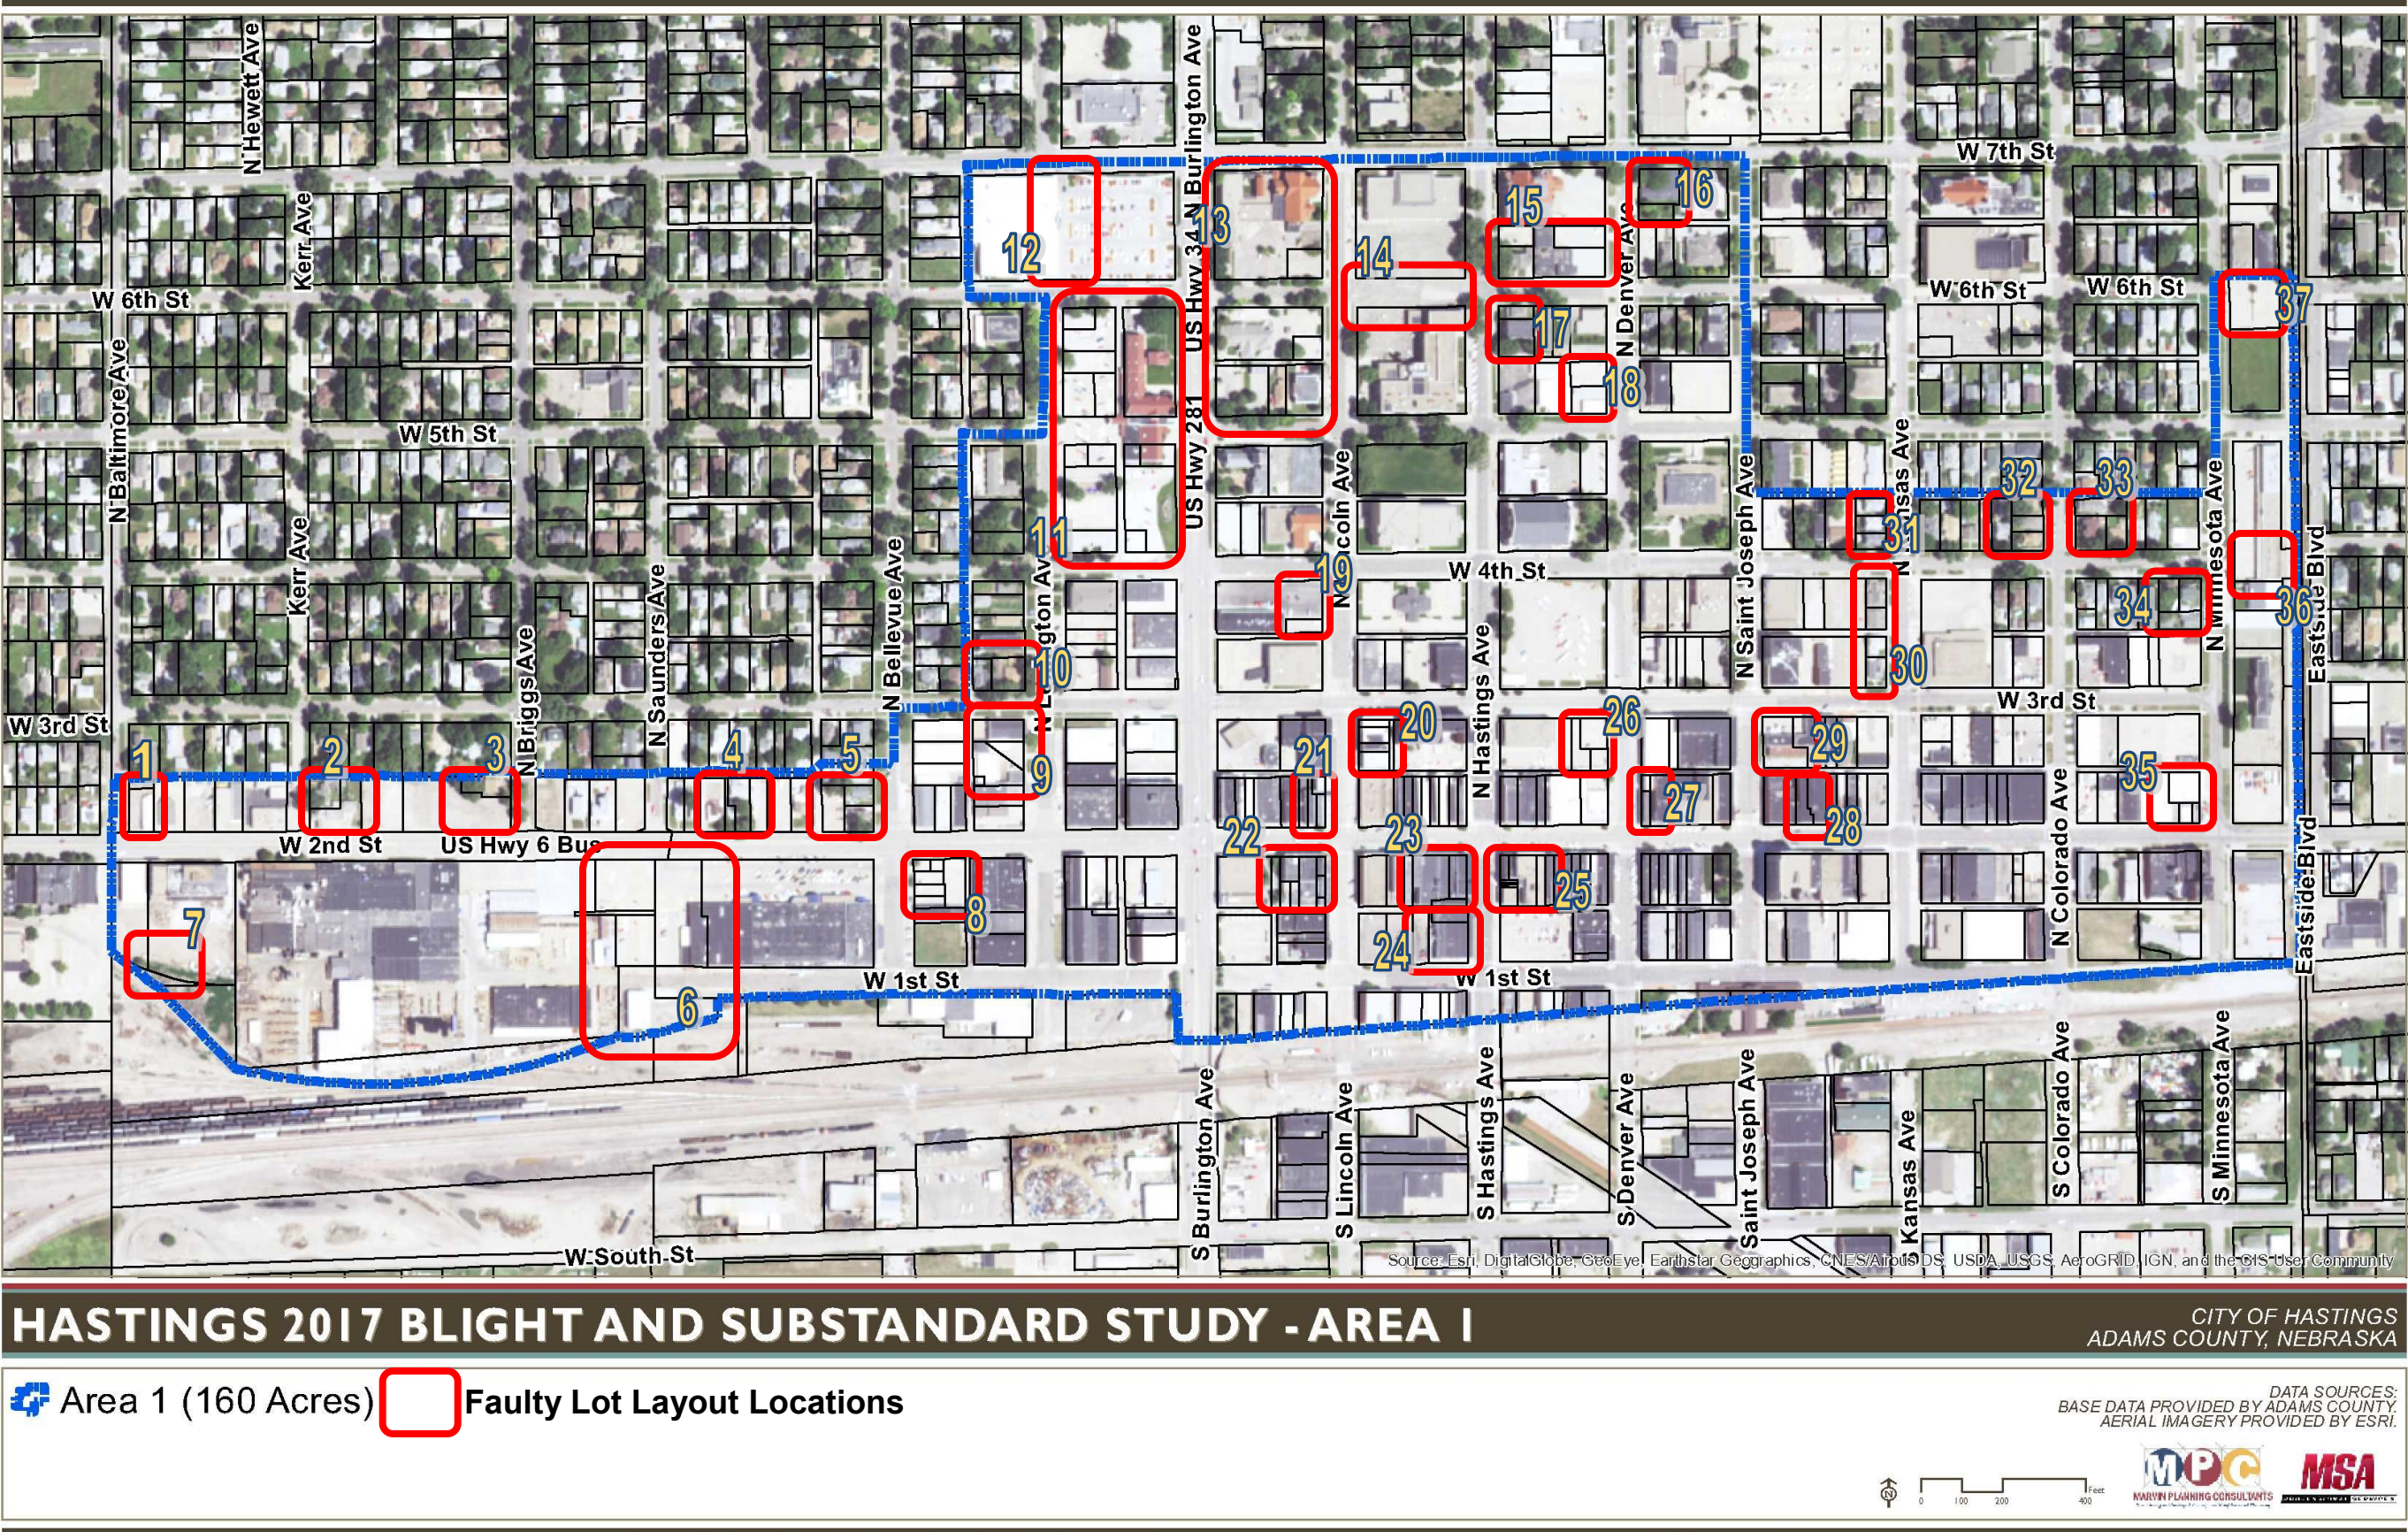
Figure 9
Faulty Lot Layout

Overall, there have been 37 areas within the study area that have this type of issue. The following listing coordinates with Figure 9 and details specifically what caused the inclusion.

Due to the number of blocks containing different platting conditions, Fault Lot Configuration is a direct contributing factor towards blighting the area.

- Where buildings are built over lot lines, these lots could be and should be combined; and
- This practice should be discontinued if it is currently used.

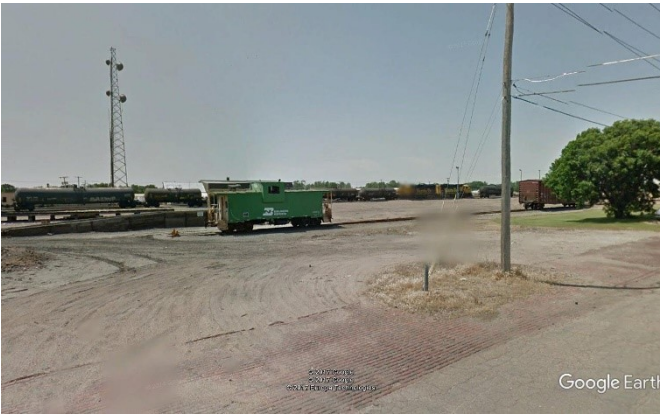
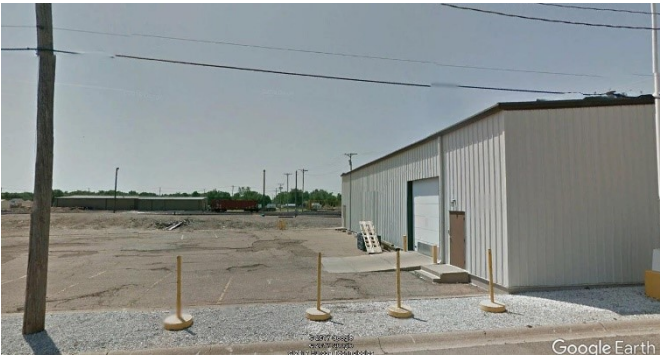
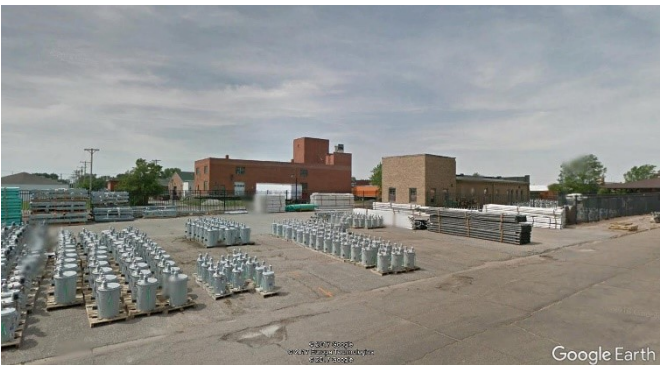
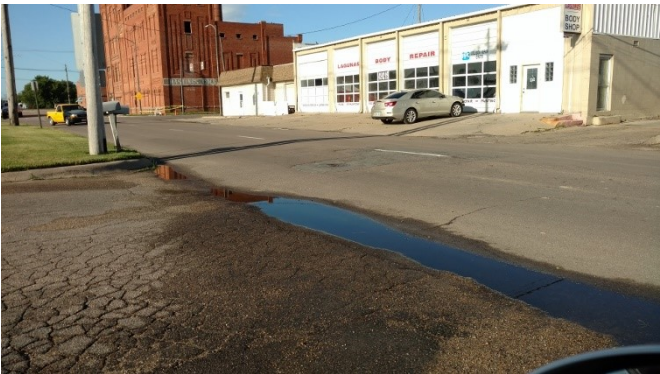
The remaining water, in the morning, is a good indicator as to where standing water can be found throughout the spring and summer months. Although it is likely the standing water along the curb and gutters will dry up and disappear in a day or so, this is still a solid indicator of possible areas in the study area which may not dry up and go away. It is important to eliminate standing water since it has a direct bearing on mosquito breeding. Mosquito in this part of the country can carry and transmit West Nile.

The BNSF Railroad's mainline runs the entire southern boundary of Area 1. In a large number of locations, the railroad right-of-way is not separated from the public rights-of-way by any sort of fencing. The lack of fencing and security allows people to gain direct access to the rails in places other than the rail crossings. The lack of security fencing is an unsafe situation. The only security fencing along the railroad R.O.W. is east of the Burlington Depot, some of which is encloses materials owned by Dutton Lainson.

Another issue considered to be Insanitary and Unsafe is the unsecured storage of transformers from Dutton Lainson along 1st Street, east of the BNSF Depot. Transformers when they are ready for use contain numerous chemicals which can be hazardous. The unsafe part of this centers on the need for these to be secured inside an area with a gate. As of the present time, anyone could drive up and begin messing with the transformers.

Examples of Insanitary and Unsafe Conditions within the Study Area
